Project: Arlington County North Side Salt Tank Structural Review

Project No: 18124.01

Purpose: Structural Conditions Survey

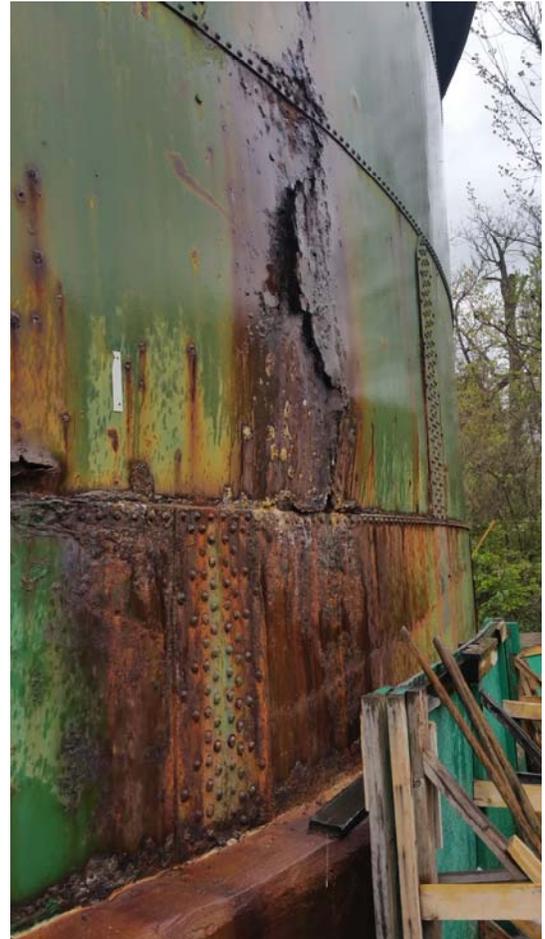
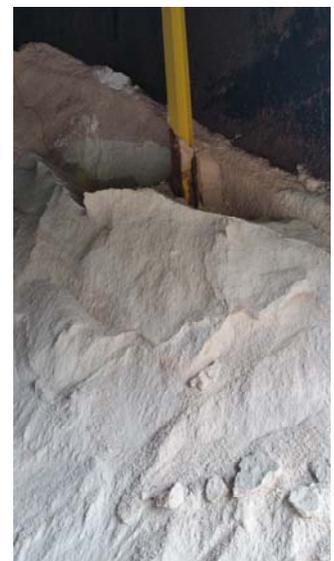
The current walkthrough noted a continuing deterioration of the existing metal plate walls and surface deterioration of the new columns installed in 2012. It also noted significant damage to the base concrete at the entrance. In some areas the perimeter steel plates have bulged (see photo above) under the pressure of the stored materials. They also are pocketed with a myriad of individual corrosion holes around the majority of the tank. These holes are of various sizes and in many occurrences the stored material can be observed as it is pressed against the walls. As it was raining during our visit we noted the wet sides of the tank and noted that the material can react with the rain water and possibly leech down the side of the tank. Some such leeching was observed. The number and concentration of the skin damage suggests the potential for a localized side wall rupture which might further expose the stored chemical to the environment.

Based on our observations it is our opinion that the extent of damage to the tank skin makes it near impossible to adequately repair. However, if it does not receive some attention it will continue to leech material (see photo on right) and likely experience additional bulges and localized failures as the material inside is loaded and unloaded. The perimeter should therefore be repaired or replaced or an

interior liner added to strengthen the remaining material and secure the stored contents. The interior steel needs attention as well to maintain the structural integrity. It needs to be abraded to remove the corrosion and then coated with a chemical resistant paint or coating. Current buried columns will need to be exposed to review their condition as well. As in the original 2012 documents the concrete damage to the base should also be repaired. Given the risks involved with the current tank situation, the costs involved to further the repair, and the unsightliness of the tank in general, the County may wish to replace the structure in its entirety.

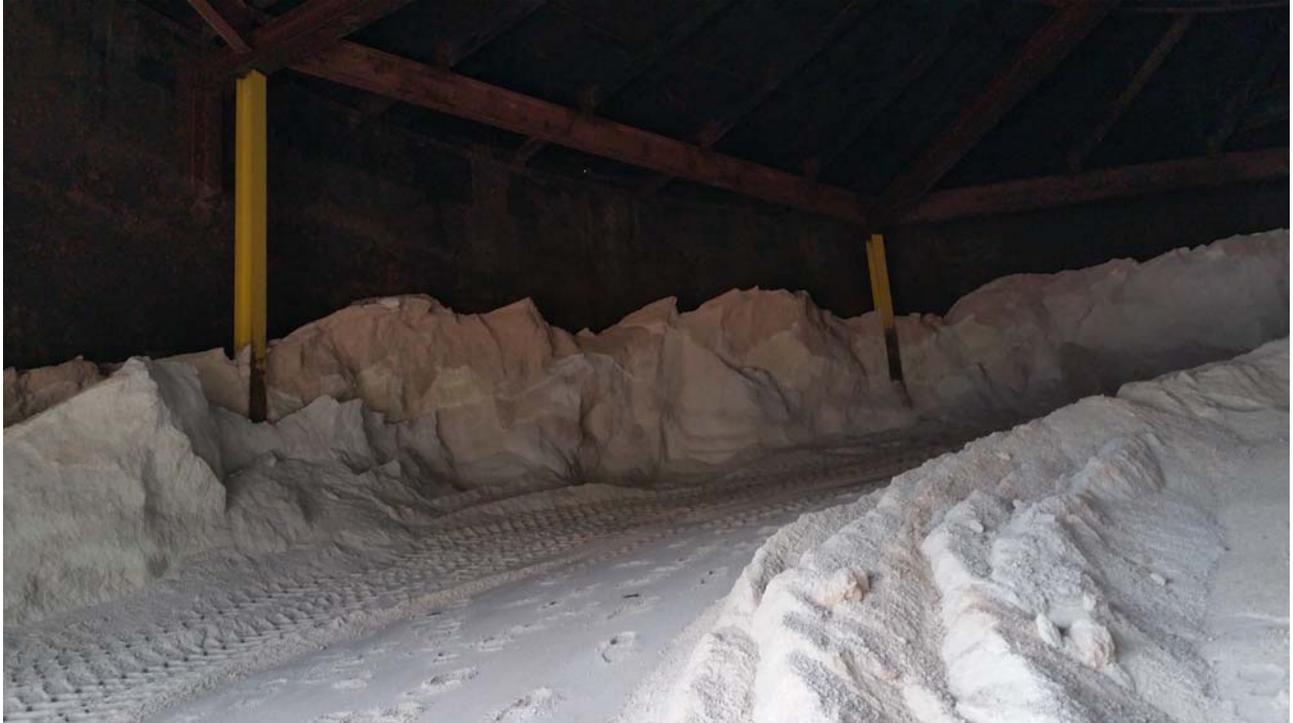
The damage noted to the perimeter skin aside, there is also corrosion on the interior columns (see above) added in the 2012 effort. This corrosion was noted on the exposed steel columns just above the stored chemical pile. The original paint has peeled under the effects of the corrosion. Only a small sample could be viewed owing to the volume of material currently stored in the building but it is likely that similar conditions occur at all the columns on some level. Surprisingly no significant roof leaks were noted during our visit. The open entrance however allows significant moisture to enter the base of the tank and puddle at the threshold. Adjacent to the threshold there is significant damage to the concrete base ring around the tank. It is not clear if this is all new damage or if original repairs were not pursued. There is exposed, corroded rebar and concrete spalls around.
